AERIAL VISUAL CONDITION REPORT

# DOMESTIC ROOF CONDITION REPORT

| Property | 14 Example Close, Wirral, CH00 0AA |
| Report reference | WDS-2026-001 |

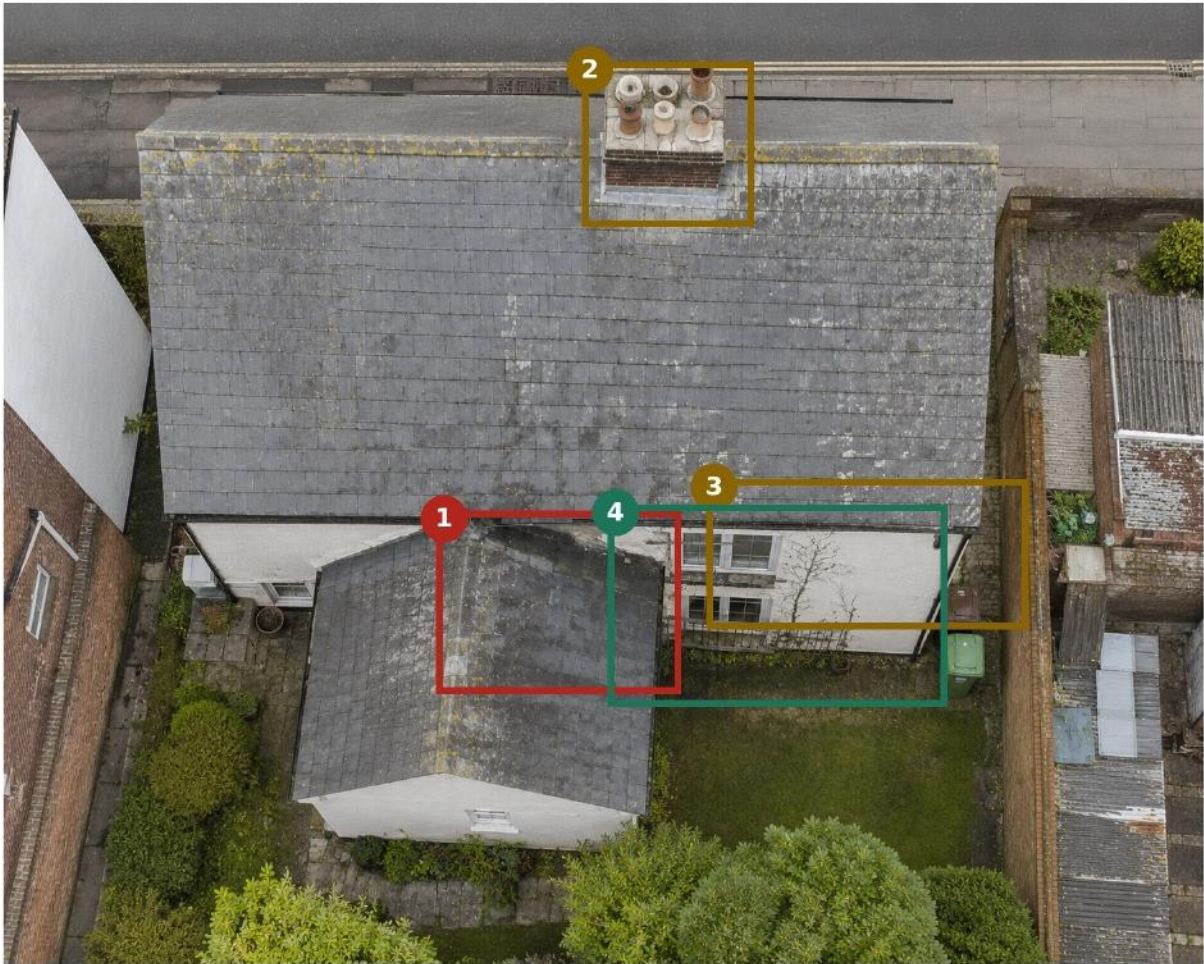
IMG-0002 • Near-vertical roof plan with finding locations

Numbered boxes identify the four findings; the complete fictional set supplies context from both roof slopes and close detail views.

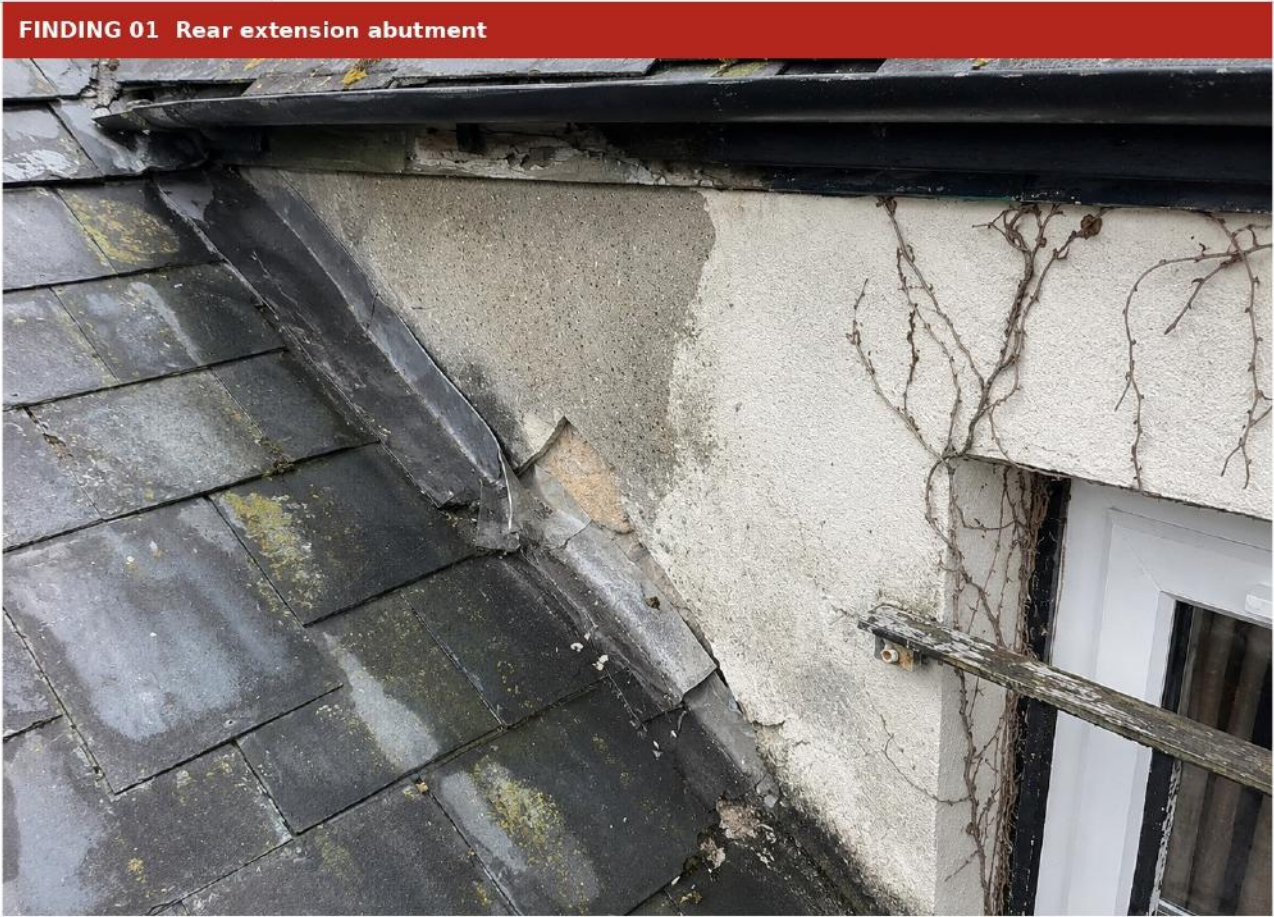
| Image reference | IMG-0006 |

| Ref | Visible condition | Priority | Suggested timing |
|---|---|---|---|
| 01 | Displaced/open weathering at rear roof-to-wall abutment | P1 | Promptly; sooner if staining is active |

Finding 01 — rear roof-to-wall abutment

The sheet weathering or flashing at the sloping roof-to-wall junction appears locally lifted, folded and open. A small area of backing material is exposed. Dark staining and loose fragments are present at the lower end of the junction.

The opening may provide a route for wind-driven rain to pass behind the external weathering layer. The image cannot confirm active leakage or the condition of concealed materials, but the visible defect justifies prompt on-site assessment.

Ask a competent roofing contractor to inspect the full abutment, confirm the existing detail and secure or renew defective material as required. If internal damp staining is active or worsening, arrange the visit as soon as practicable and avoid unsafe temporary access.

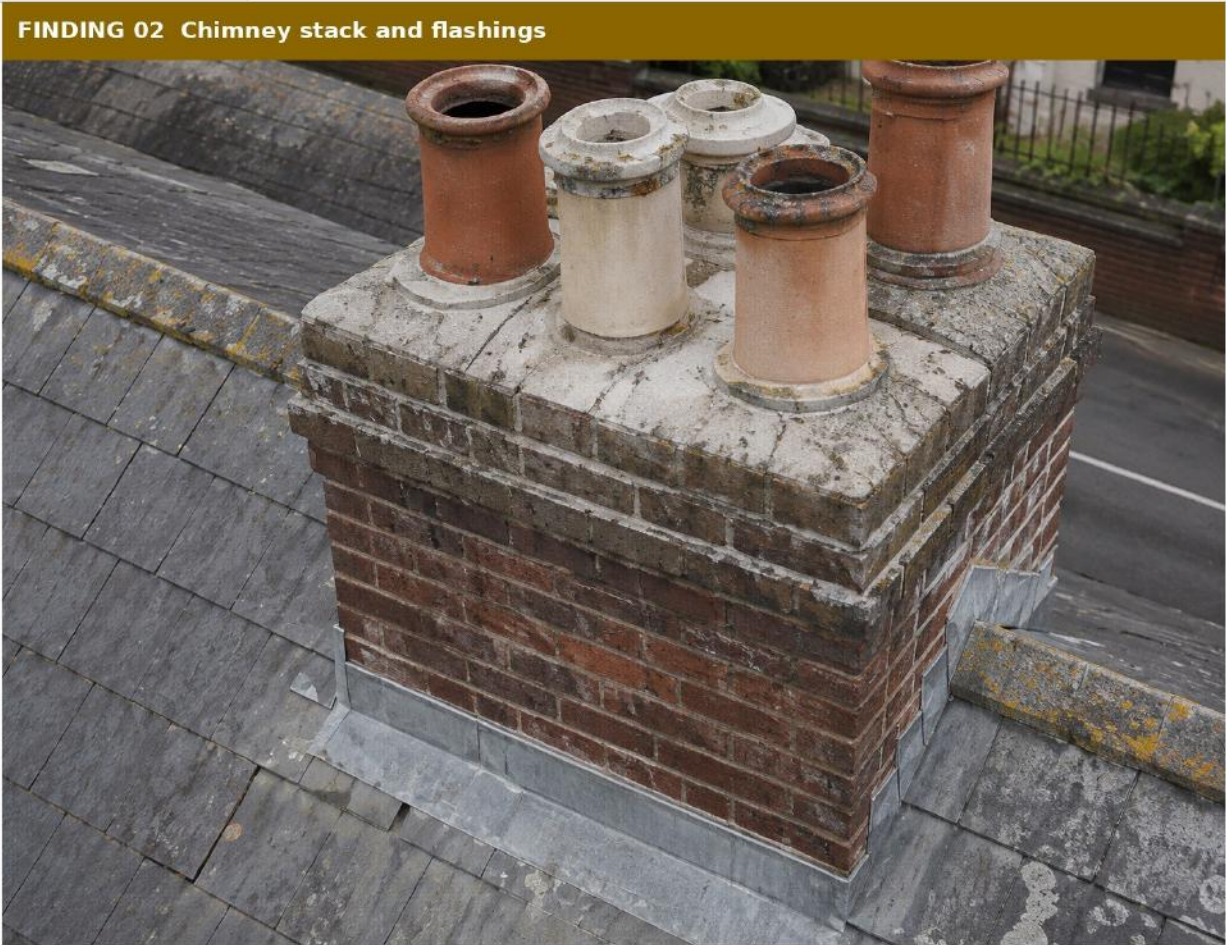
IMG-0005 • Chimney detail

| Ref | Visible condition | Priority | Suggested timing |
|---|---|---|---|
| 02 | Weathered chimney mortar/flaunching and local flashing distortion | P2 | Within 1–3 months |

Finding 02 — chimney stack and flashings

Localized weathering and open mortar joints are visible within the upper brickwork. Hairline cracking and surface deterioration are present to the cement flaunching around the pots. One short section of lead weathering appears slightly distorted.

Deteriorated mortar or flaunching can admit moisture and may progress through freeze–thaw exposure. Distorted leadwork can reduce the reliability of the weathered junction. No loose masonry or immediate collapse risk is evident in this view.

Include the chimney in the roofer's on-site inspection. Ask them to check mortar stability, pot security, flaunching and all lead soakers/aprons, then quote for localized repointing or compatible repairs where required.

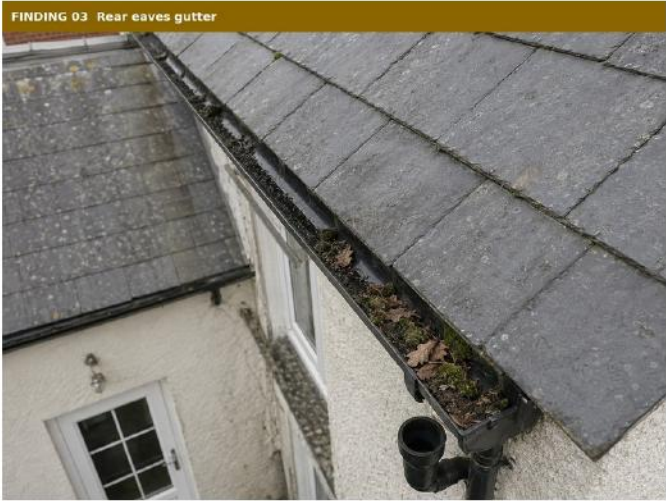
Finding 03 — rear gutter

| Ref | Visible condition | Priority | Suggested timing |
|---|---|---|---|
| 03 | Leaf, moss and silt build-up in rear gutter near outlet | P2 | Next safe maintenance visit |

**Visible observation:** Leaf fragments, moss and silt are accumulated in the rear gutter close to the outlet area. The outlet is not shown under flow conditions.

**Recommended action:** Arrange safe gutter clearance and check that the outlet and connected downpipe discharge freely. Review after heavy rainfall for overflow or staining.

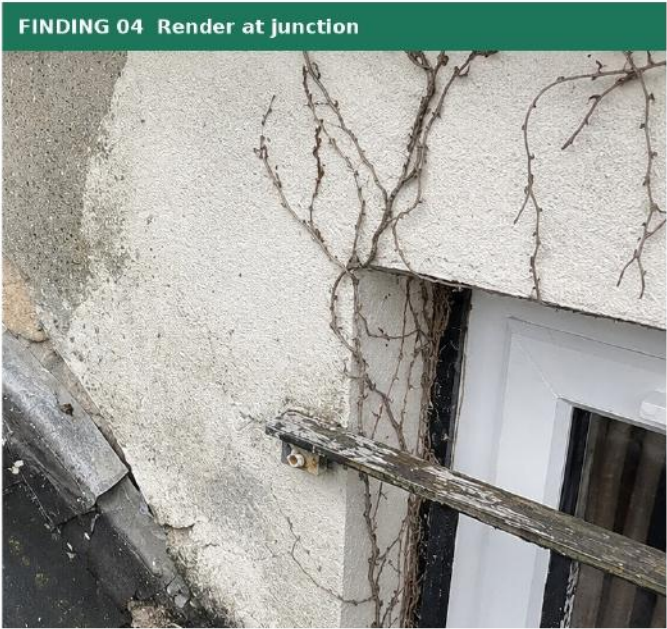
Finding 04 — cracked render

| Ref | Visible condition | Priority | Suggested timing |
|---|---|---|---|
| 04 | Cracked and locally missing render beside the abutment | P2 | Coordinate with junction repair |

**Visible observation:** Cracking, open edges and local render loss are visible beside the abutment and window reveal. Backing material is exposed locally.

**Recommended action:** After the abutment detail is made sound, ask a suitable contractor to remove loose material and complete a compatible weatherproof render repair.
